SERVICE INSTRUCTION 02/11

Publication Ref. Number: 099

Cylinder strapping.

Large Ultramagic baskets with Single or Double T Type partition

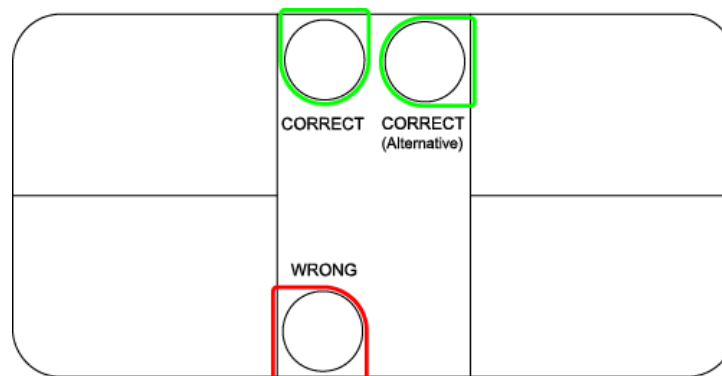
It has been found that repeated incorrect strapping of cylinders could lead to a premature distortion of the basket woven wall.

To prevent this possibility, check that the cylinder straps are installed according to the following scheme:
